HYUNDAI Technical Service Bulletin	GROUP AUTOMATIC TRANSMISSION	NUMBER 20-AT-017H
	DATE MAY, 2020	MODEL Accent (RB), Azera (TG/HG), Elantra (UD/MD/GD/JK), Santa Fe (CM/AN/NC), Sonata (YF/YF HEV, LF/LF HEV/PHEV), Tucson (LM/TL), Veloster Turbo (FS)
SUBJECT: AUTOMATIC TRANSMISSION DTC P0880/P088000

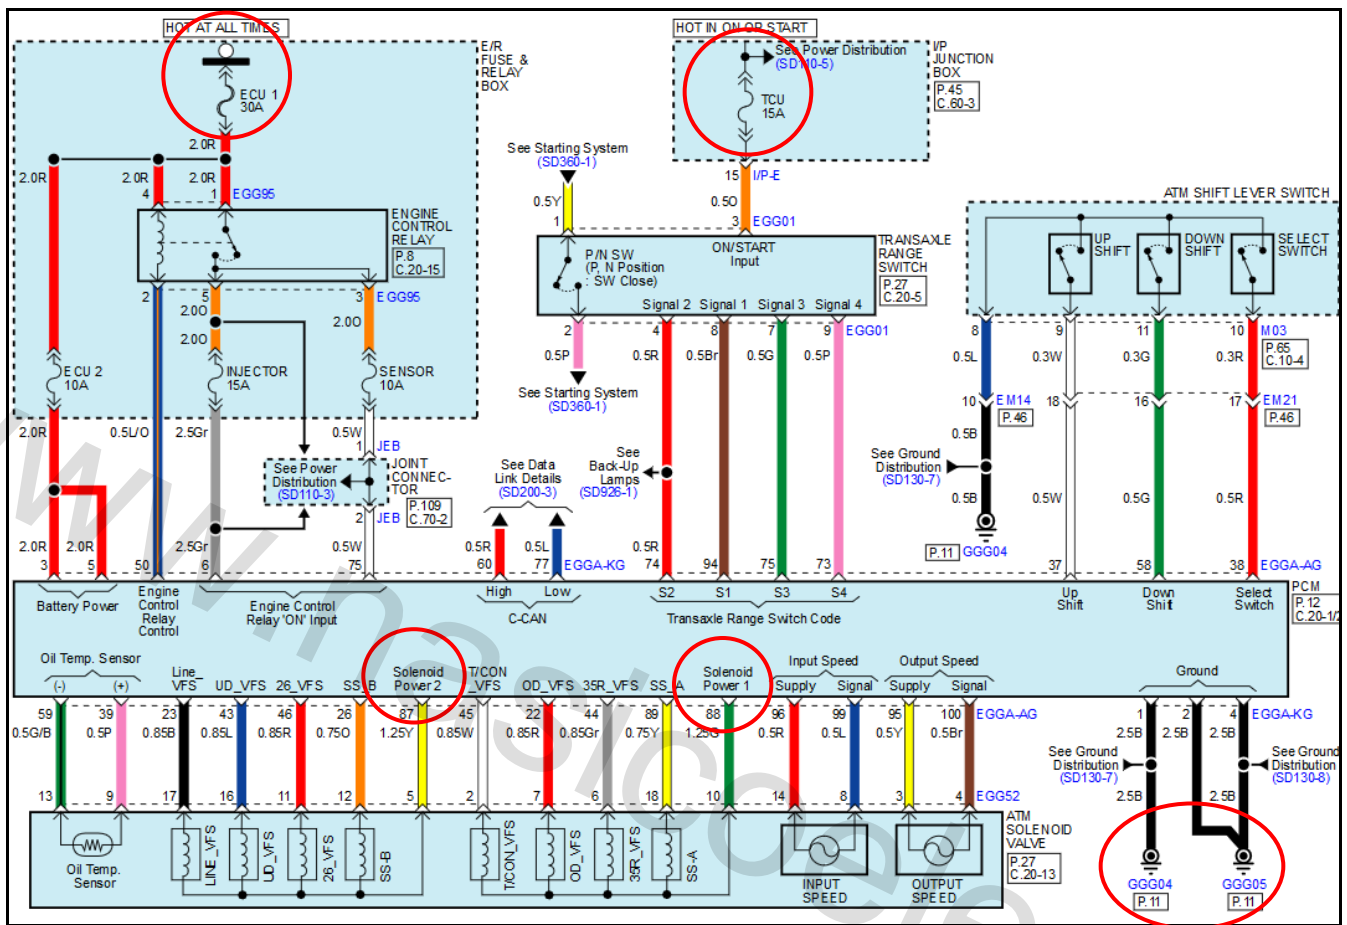
ETM INFORMATION: Example only – refer to the related shop manual

P0880/P088000 is set when solenoid power voltage is lower than 7v or higher than 22v.

Possible Causes: Poor connection/circuit fault or faulty PCM.
